LAKE STATES ASPEN REPORT NO. 9

ASPEN LUMBER FOR BUILDING PURPOSES

BY
LOUIS W. REES
MINNESOTA AGRICULTURAL EXPERIMENT STATION
UNIVERSITY OF MINNESOTA

DECEMBER 1947

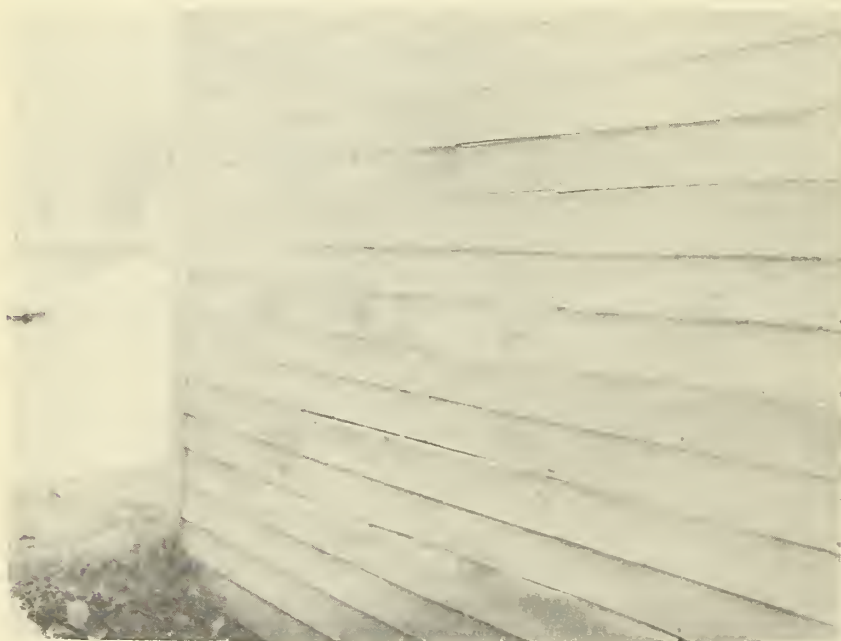
Figure 1.--The white streaks show the amount of shrinkage in green aspen bevel siding after one year of service. It is also evident that the overlap was not sufficient. The foundation is too low to protect the lower courses of boards from ground moisture. Photo by Forest Products Laboratory.

Perhaps some of the other properties of aspen wood can best be brought out by comparison with a well-known structural wood such as eastern white pine. At 12 per cent moisture content, aspen is slightly heavier than eastern white pine. It has more shrinkage than eastern white pine, but less than that of many other woods used for similar purposes. With improper seasoning, as for most other woods, shrinkage may be considerable (see figure 1).

It is important that good construction practice be followed in applying any siding. Bevel siding is lapped $\frac{3}{4}$ inch for 3-inch siding, 1 inch for 6-inch siding, and 1 $\frac{1}{2}$ inch for siding over 6 inches. This lap is sufficiently great so that a nail will go through the bottom portion of one piece and through the top of the piece beneath. Failure to provide enough overlap is illustrated in figure 1, where most of the nails missed the top edge of the boards entirely.

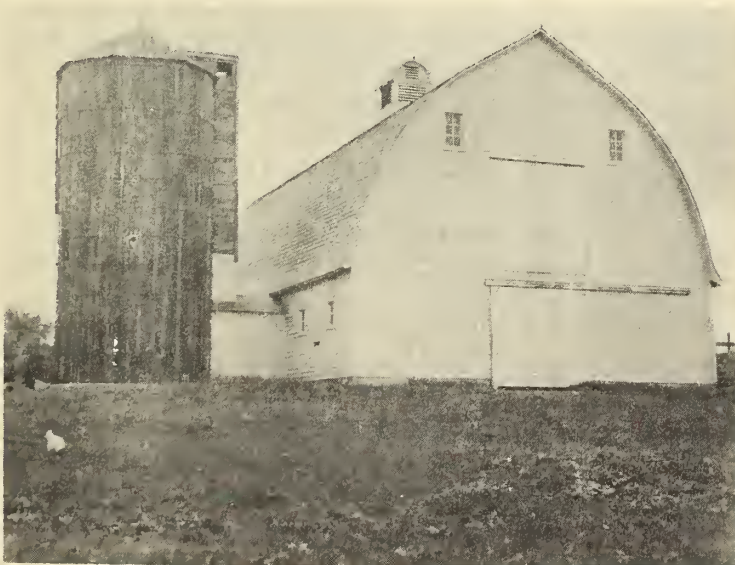
Figure 3.--Dairy barn constructed in 1942 using about 90 percent aspen lumber.

girder posts, joist, studding, rafters, sheathing and roof boards, sub-floors, flooring of various types, interior finish and often in the form of drop siding or bevel siding for exterior finish. In some cases, it is also used for shingles. A dairy barn, located near Bagley, Minnesota, built in 1944, was constructed entirely of aspen, even to the shingles. Another dairy barn (see figure 3) which was built in 1942 near Waubon, Minnesota, used the following material (almost all local wood):

1. Sill - northern bur oak
2. Girder posts - aspen
3. Girders - aspen and northern bur oak
4. Girder caps - northern bur oak
5. Joist - aspen and some northern bur oak
6. Mow floor - aspen - 6-inch flooring
7. Studding - aspen
8. Plate - northern bur oak
9. Rafters - (bent type) aspen
10. Sheathing and roof boards - aspen
11. Exterior finish - basswood bevel siding
12. Shingles - western red cedar
13. Window frames - aspen
14. Stanchions, stalls, and mangers - aspen

It is not intended that this list should indicate the wood best suited for a given purpose. It is merely an outline of the different woods used in construction of this particular barn. However, the barn is well constructed. The foundation is about 8 inches above the floor on the inside. The girder posts are set on a cement base projecting about 6 inches above the cement floor level. A durable wood was used for the sill and the inside of the barn is well ventilated. Many other cases could be cited with minor variations from the outline given above.

Since aspen wood is not strong and often contains defects, it must be used with a certain amount of caution for framing materials such as studding, joists, and rafters. For small buildings such as chicken houses, garages, granaries, and small houses, aspen 2 x 4's are strong enough for studding and in many cases for rafters, especially where the rafter is short. In large buildings such as dairy barns, the studding should be made of 2 x 6's and the joist, not over 12 feet long, of 2 x 8's or larger. The joists in the barn shown in figure 3 are mostly aspen 2 x 8's. However, a few joists of the same size are made of northern bur oak.

That aspen lumber can be used for flooring has been amply demonstrated. The mow floor in the barn shown in figure 3 was made of 6 inch aspen flooring. A planing mill at Bagley, Minnesota, was floored with 2 inch rough aspen planks. An aspen store floor in a northern Minnesota town was laid in 1908 and was still in use after 34 years of service. Properly seasoned aspen flooring appears to wear smoothly.
